**Flood Control Project Maintenance
Levee Inspections**
LMA District Cover Sheet
Spring 2018 Levee Inspection Results

Reclamation District No. 0817 Carlin

Spring 2018 Levee Inspection Results

Waterway			Bank	Unit Miles
Unit No. 01 South Dry Creek			Left	3.81
	Spring (March - May)	Summer (June - August)	(September - November) Fall	Winter (December - February)
Unit Maintenance Rating (Fall Only)				
Date of Inspection	4/18/2018 - 4/18/2018			
DWR Inspector	Sterling York			
Accompanied By	Joe Conant RD 817			
	Tom Engler RD 2103

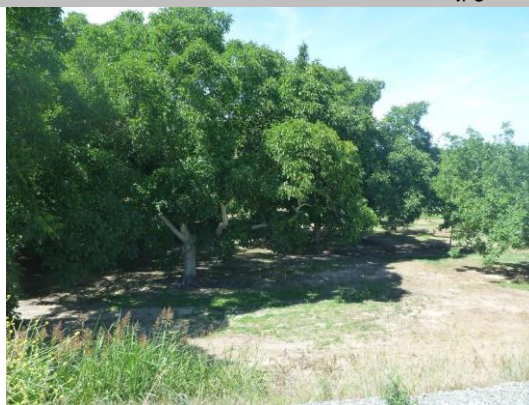
Photo 1 of 3 : LEVAL_SP_2018_162_287.jpg

LM Start	2.08	Rating **	A/W	Issue No.	13	
LM End	3.18	Issue Type +	Ma	Location *		
Category	Supplemental			GPS Latitude/Longitude		
				Start	End	
Item	2017 Storm Damage			38.989338 °	38.994124 °	
				-121.468640 °	-121.449448 °	
DWR ID	DWR_RD0817_02_f_2017_13					
Comment Code						
Inspector Comment						
Levee Evaluation Comments						
Description:						
Site ID No:162						
Site Designation:DWR_RD0817_02_s_2012_10						
Repair Type: Stability						
Rating:Area of Concern						
Field Date:6/5/2017						
Notes: Stability issues are due to levee geometry. Narrow steep slopes.

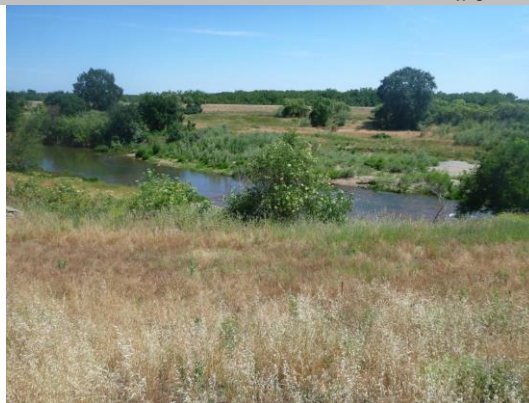
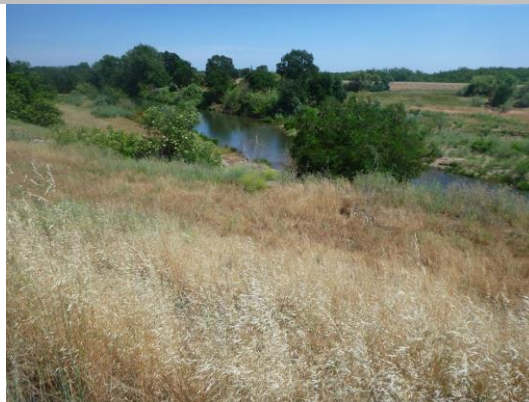
LM Start	2.08	Rating **	A/W	Issue No.	13 (cont)	
LM End	3.18	Issue Type +	Ma	Location *		
Category	Supplemental			GPS Latitude/Longitude		
				Start	End	
Item	2017 Storm Damage			38.989338 °	38.994124 °	
				-121.468640 °	-121.449448 °	
DWR ID	DWR_RD0817_02_f_2017_13					
Comment Code						
Inspector Comment						
Levee Evaluation Comments						
Description:						
Site ID No:162						
Site Designation:DWR_RD0817_02_s_2012_10						
Repair Type: Stability						
Rating:Area of Concern						
Field Date:6/5/2017						
Notes: Stability issues are due to levee geometry. Narrow steep slopes.

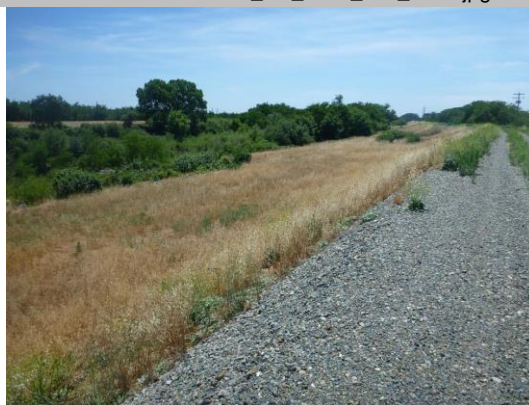
Photo 1 of 3 : LEVAL_SP_2018_161_1065.jpg

LM Start	2.72	Rating **	A/W	Issue No.	14
LM End	2.74	Issue Type +	Ma	Location *	
Category	Supplemental			GPS Latitude/Longitude	
				Start	End
Item	2017 Storm Damage			38.992170 °	38.992217 °
				-121.457332 °	-121.456967 °
DWR ID	DWR_RD0817_02_f_2017_14				
Comment Code					
Inspector Comment					
Levee Evaluation Comments					
Description:					
Site ID No:161					
Site Designation:240-3					
Repair Type: Erosion					
Rating:Area of Concern					
Field Date:6/5/2017					
Notes: No issue found. Narrow levee with steep slopes. Did not investigate bench due to rattlesnake concerns. Possible alternate location at 38.993282; -121.451562.

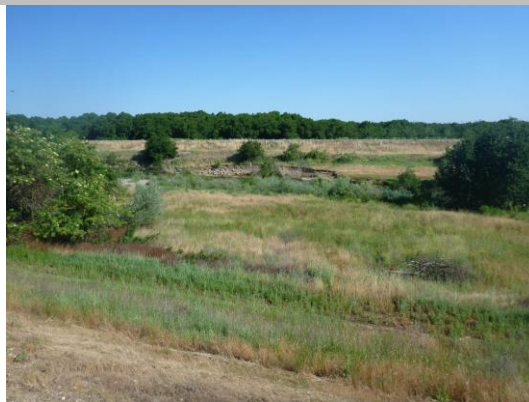
Photo 3 of 3 : LEVAL_SP_2018_161_291.jpg

LM Start	2.72	Rating **	A/W	Issue No.	14 (cont)
LM End	2.74	Issue Type +	Ma	Location *	
Category	Supplemental			GPS Latitude/Longitude	
				Start	End
Item	2017 Storm Damage			38.992170 °	38.992217 °
				-121.457332 °	-121.456967 °
DWR ID	DWR_RD0817_02_f_2017_14				
Comment Code					
Inspector Comment					
Levee Evaluation Comments					
Description:					
Site ID No:161					
Site Designation:240-3					
Repair Type: Erosion					
Rating:Area of Concern					
Field Date:6/5/2017					
Notes: No issue found. Narrow levee with steep slopes. Did not investigate bench due to rattlesnake concerns. Possible alternate location at 38.993282; -121.451562.
